Water treatment plant 'Mochita' *Concepcion - Chile*

1 Introduction

This briefing note covers the water treatment plant 'La Mochita' in Concepcion, Chile and provides image analysis of the facilities of the water treatment plant. The water treatment plant is very likely to be damaged due to the recent earthquake. The information is based on a Quickbird multispectral image, dated 03 January 2008 (before the earthquake), which has been combined with open source collateral information. No post-event imagery was available at the time of writing (03/03/2010). The information is based on news and information collected via open source information.

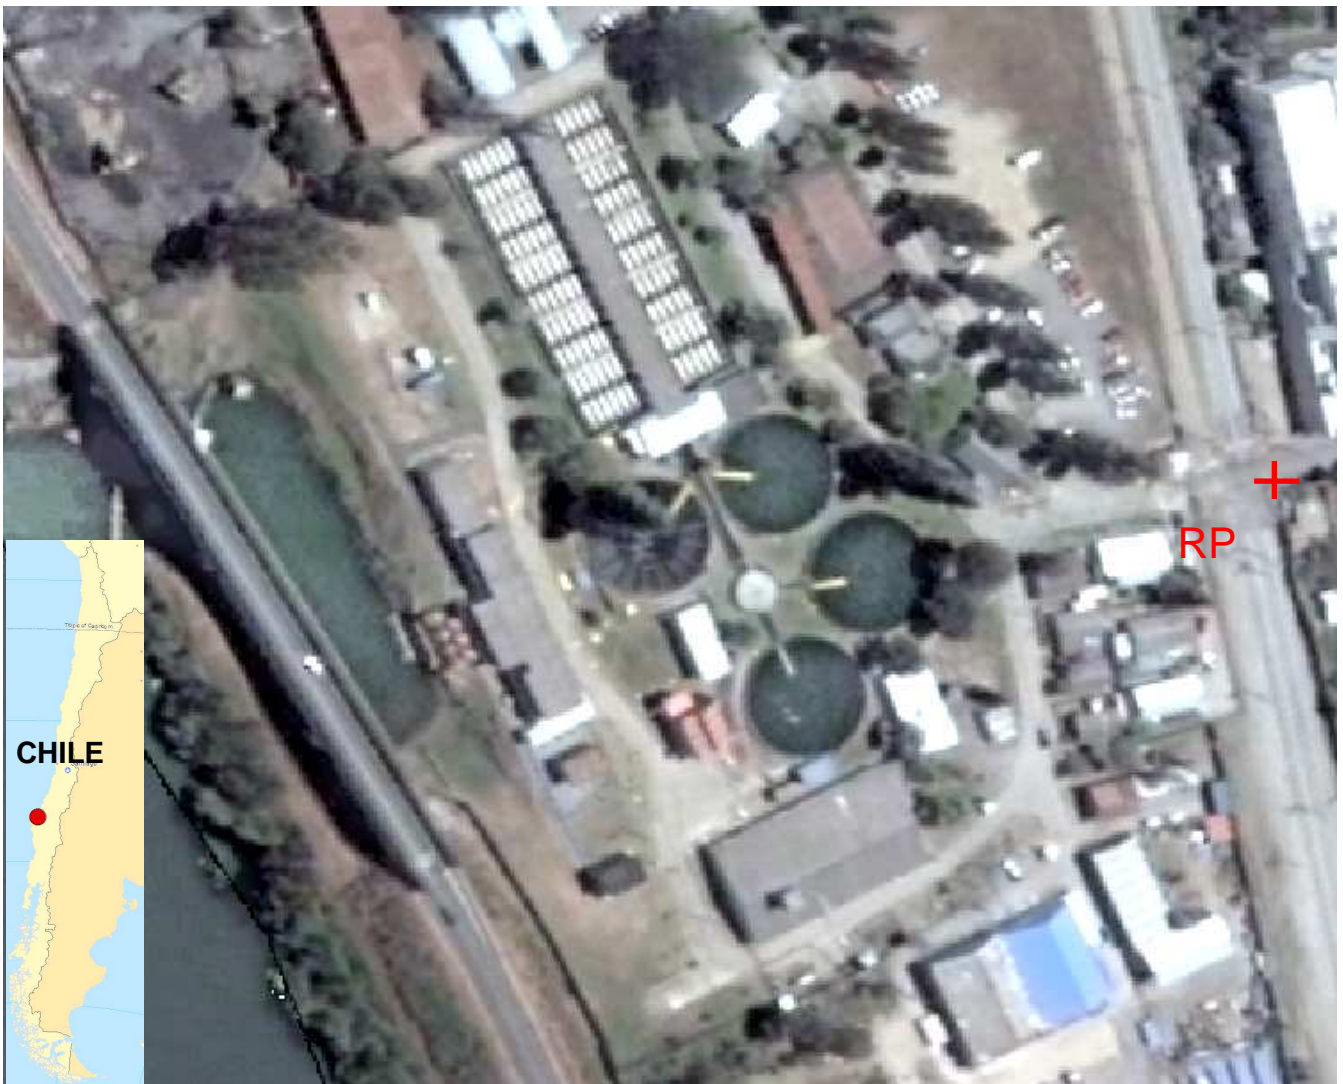
RP: 36°50'47"S 73°3'11"W

Image: Quickbird MS/Pan sharpened
Date: 03/01/2008

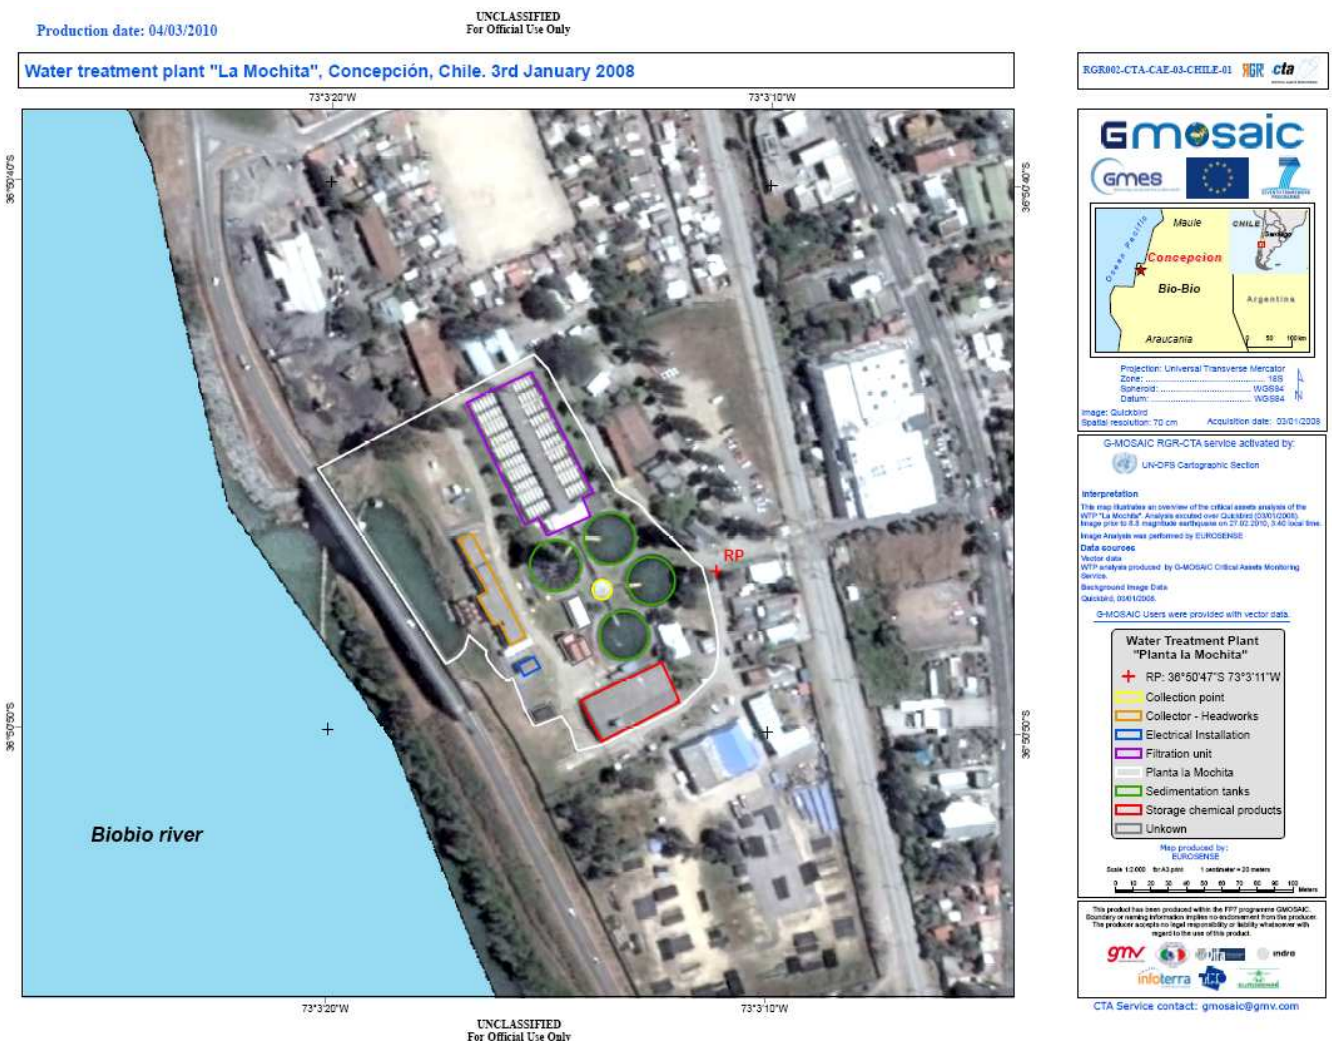
3 Description of facilities

The plant is capturing water directly from the Biobío river. It enters the water treatment plant via the **Collector – Headworks** infrastructure, where a first filtration is done. The largest contaminants are removed here. After the first filtering, the water is pumped to the sedimentation tanks.

In the **sedimentation tanks**, the retention of suspended solids takes place. La Mochita has 4 sedimentation tanks, with a diameter of 30m each, a volume of 3350 m³ c/u and a maximum capacity of 750 l/s.

A 3rd filtering stage is done in the **filtration unit**. The retention of suspended solids is finalized here. The filtration unit has 9 operational units and 11 units that are out of service since 1998.

The filtered water is transported to water ponds located in 'Cherre Chepe' and 'Cerro Caracol'. Cerro Chepe is supplying Concepcion, Cerro Caracol is supplying part of Talcahuano. 4 groups of pumping units with a capacity of 285 l/s c/u are used to supply Cerro Chepe. 3 groups of pumping units with a capacity of 290 l/s c/u are used to supply Cerro Caracol.

The **chemical storage** unit allows the injection of chemical products to assist the retention of suspended solids. The products used are aluminum-sulfate, lime and chlorine.

An **electrical installation** is used to supply the Mochita plant with power. There are 4 transformers of 1600 KVA each on the site. (source: <http://www.essbio.cl>)
